# Floating head heat exchanger tube repair

Hank Brandenberger, Expansion Seal Technologies, USA, introduces a hydraulic solution to the problem of repairing leaking tubes in floating head heat exchangers.

# Through the Tube Plugging in RHR Heat Exchanger Saves in Excess of \$75,000

### **Do-it-yourself tube plugs** stop heat exchanger leaks

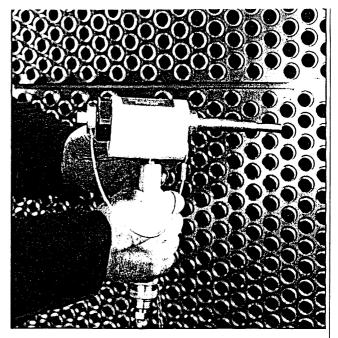
Hydraulic ram tool installs new tube plugs in seconds at Winyah generating station in South Carolina.

The plugs use a mechanical wedge operating principle. They have a tapered pin inside a tapered ring. The ring has 10 to 12 peripheral serrations. As the hydraulic ram draws the pin and expands the ring. each serration forms a seal with the tube wall. The ring is annealed so it neither penetrates the tube wall nor deforms the tube sheet. The plug usually can be installed in the prepared end of a tube within 15
