“NORTH ANNA MAIN CONDENSER TUBE PLUGGING METHOD REDUCES CONTAMINANTS”

(Presented at EPRI Condenser Technology Conference, September 1999)

AN IMPROVED PLUGGING SYSTEM FOR HX TUBING

“THROUGH-THE-TUBE PLUGGING APPLICATION FOR ONCE THROUGH HEAT EXCHANGERS”

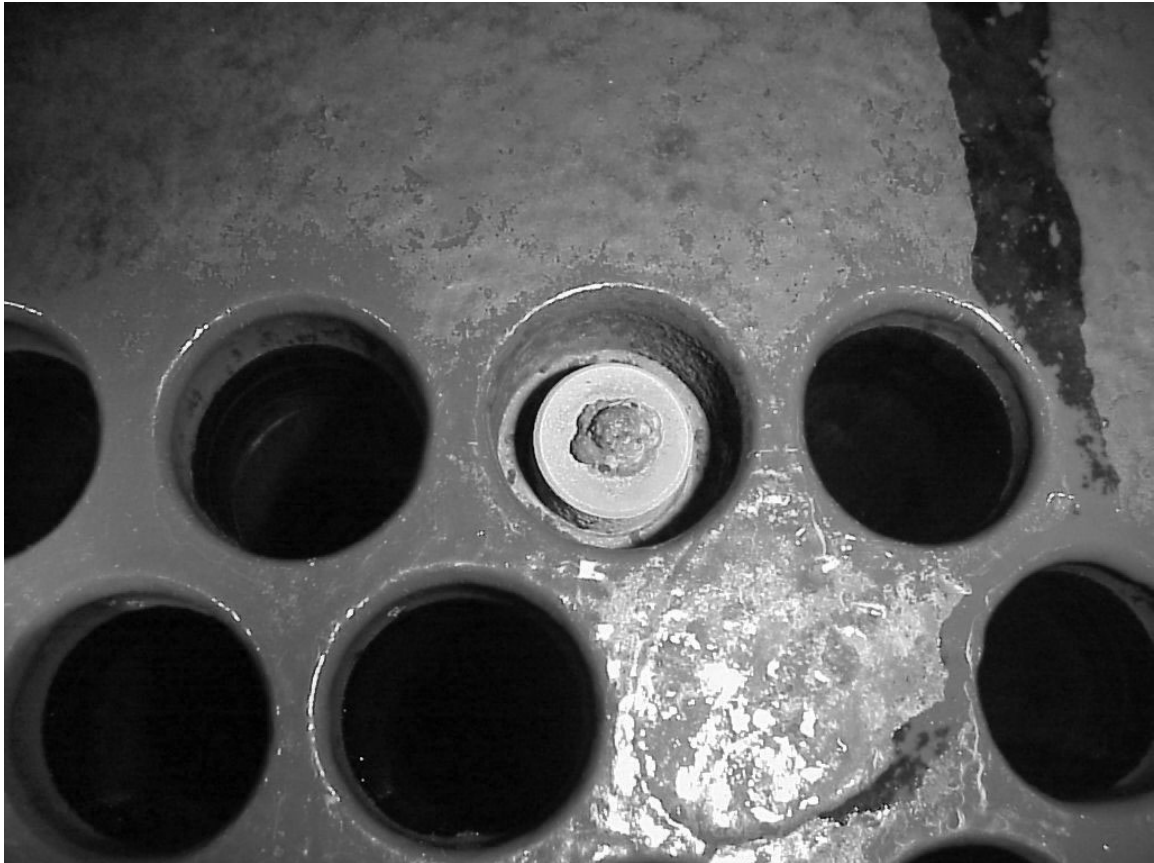
Figure 2. Installed Perma Plug

The Perma Plug was determined to be the best plug for this application for two reasons. The plug could be inserted into the tubesheet below the tubesheet surface. Therefore the plug could be installed without having to remove any coating. The Perma Plug also helps reseal the tube into the tubesheet as the sealing ring expands and deforms on the tube ID. This is a secondary function of the plug's sealing method. North Anna has had Pop-A-Plugs installed in the main condensers for 5 years with no failures. The photographs attached show plugs that have been installed in North Anna main condensers since 1994.

The type of tube plug that North Anna used in the main condenser was a tapered plug that is driven into the tube to seal the leaking tube. During the investigation that was started in 1994 to reduce condenser leakage, there was found approximately 300 tube plugs leaking in both units. The taper plug used was made of stainless steel and a taper of as much as 10 mils per inch was used. There were several problems found with this plug. The taper that was used on these plugs was too large and over several heat up cycles it would allow the plug to become loose. The use of stainless steel also did not allow the plug to conform to the tube. Therefore the plug would not actually contact the tube all the way around circumference due to roundness of the tube in the tubesheet. The removal of these plugs showed that in most cases the plug contact with the tube was less than 150 degrees F. The removal of these plugs required a major effort because even though the plugs were loose the stainless steel plugs had galled against the stainless steel tube. The repair of these plugs required 8 shifts to remove the 300 plugs that were leaking and approximately 2 shifts to replace them with Pop a Plugs (See Figure 2).

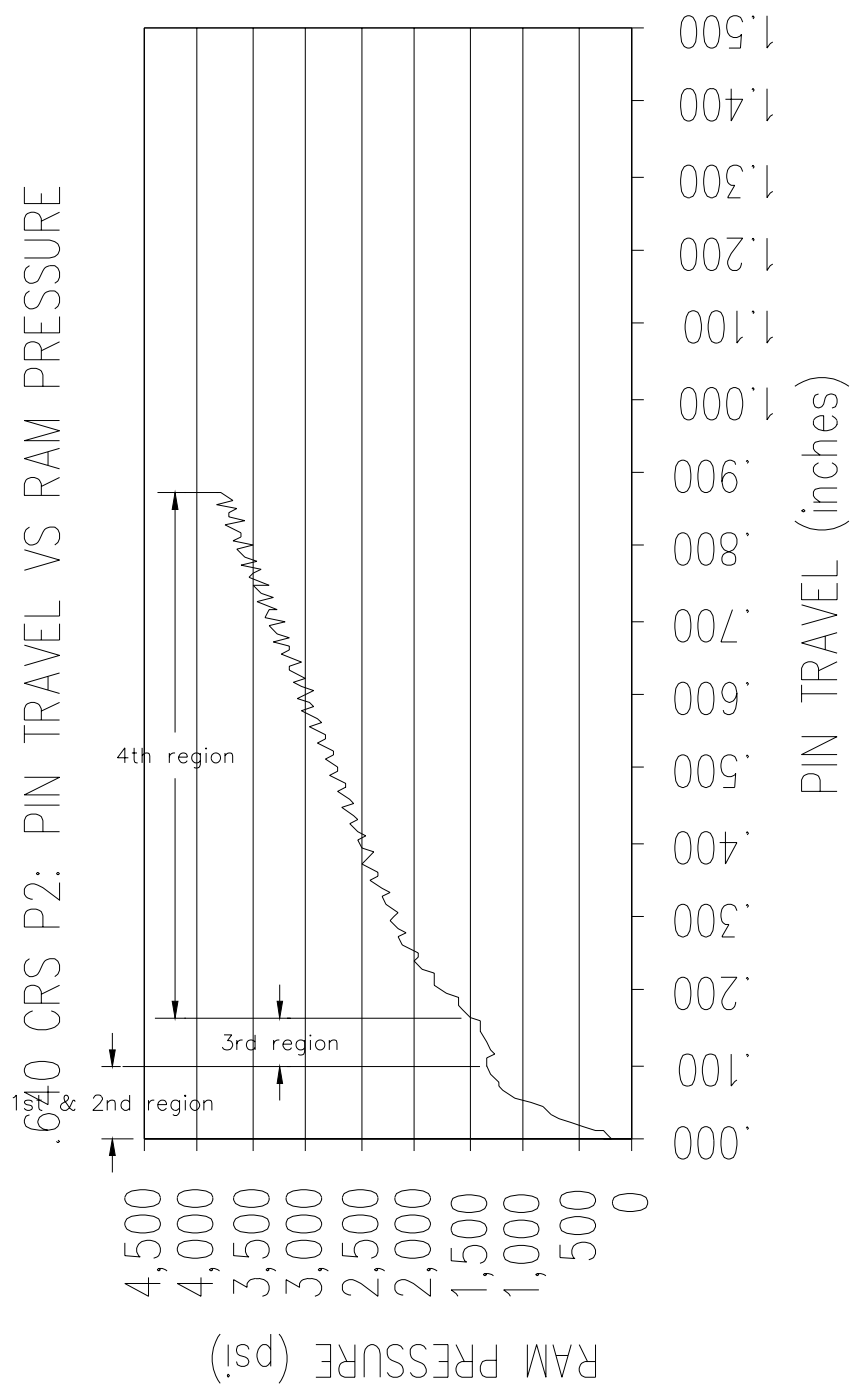
FIGURE 8B

NEW P2 POP-A-PLUG DESIGN

It was found that internal serrations shown in the patented P2 plug² design of Figure 9 reduce the third region force. This design also shapes the ring so that it

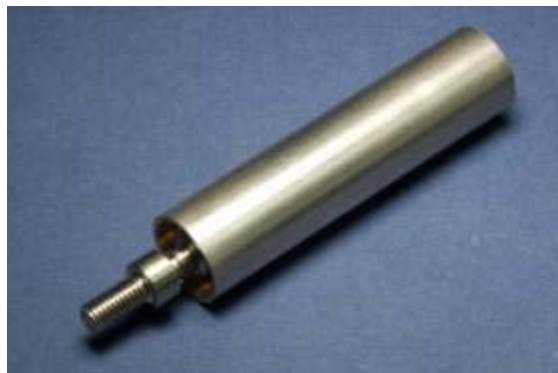
A stabilizer anchor provides the means to firmly fix one end of the tube stabilizer assembly in position thereby limiting movement of the stabilizer within the tube. EST has adapted Pop-A-Plug technology to create an effective anchor, see Figure 1. EST's Stabilizer Anchor consists of an appropriately sized Pop-A-Plug inside a thimble. The thimble is drilled and tapped on the end opposite the plug so that it can be threaded onto the end of the stabilizer rod or cable assembly. Pop-A-Plug Anchors are sized very much like P2 Pop-A-Plugs - they are available in 0.020" (0.5mm) increments to fit tube ID's ranging from 0.501 inches to 0.980 inches (12.7 to 24.8mm). The Anchor is set using a Pull Rod assembly and the same hydraulic ram that is used to install Pop-A-Plugs. As the plug is pulled the ring expands within the thimble and the thimble within the tube effectively locking the stabilizer assembly in place. Since the anchor body is smooth and the anchor installation may occur beyond the tube sheet the anchor should not be relied upon to seal the tube. Once the anchor has been set, Pop-A-Plugs are typically installed at either tube end to seal the tube.

Figure 1. Pop-A-Plug Tube Stabilizer Anchor Assembly

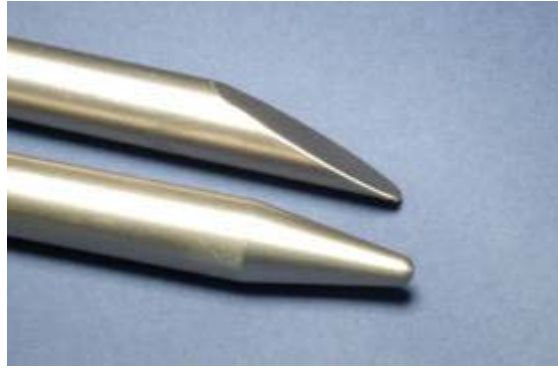
In addition to either the rod or cable type stabilizer EST offers two tip configurations, a wedge type and a bullet type, see Figure 2. The wedge type is used to help capture and realign broken tubes. The bullet type is more commonly used. Stabilizer tips like stabilizer rods are available in any length in order to accommodate tube end clearance limitations – typical tip / segment lengths range from 1 foot to 6 feet (304 to 1829mm).

Figure 2. Tube Stabilizer Tips, Wedge Type (top) and Bullet Type (bottom)
